### Replacing an ageing platform lift to improve reliability at a Cornish school.

## CAMBORNE COMMUNITY COLLEGE PLATFORM LIFT

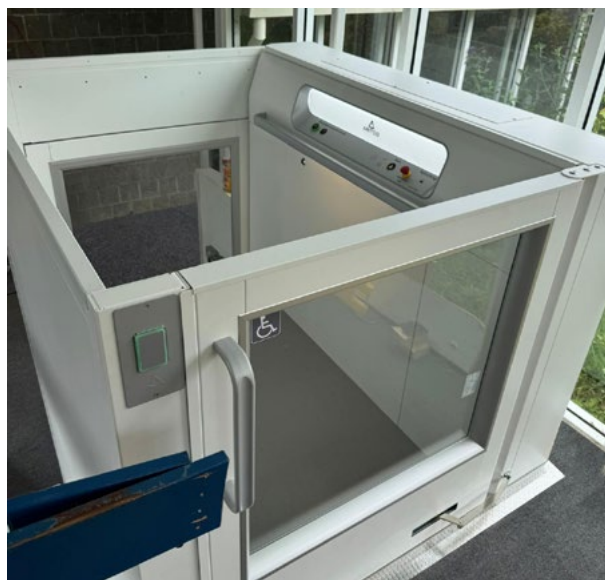
enclosed platform lift capable of carrying a wheelchair user or standing passengers. The lift was designed to be fully enclosed at the ground floor level and open on all sides from its 1000 mm x 1480mm platform once stationary at the upper level and installed with through-type doors.
